# Water Leak on Spool Elbow Problem Scenario

# Water Leak on Spool Elbow Solutions

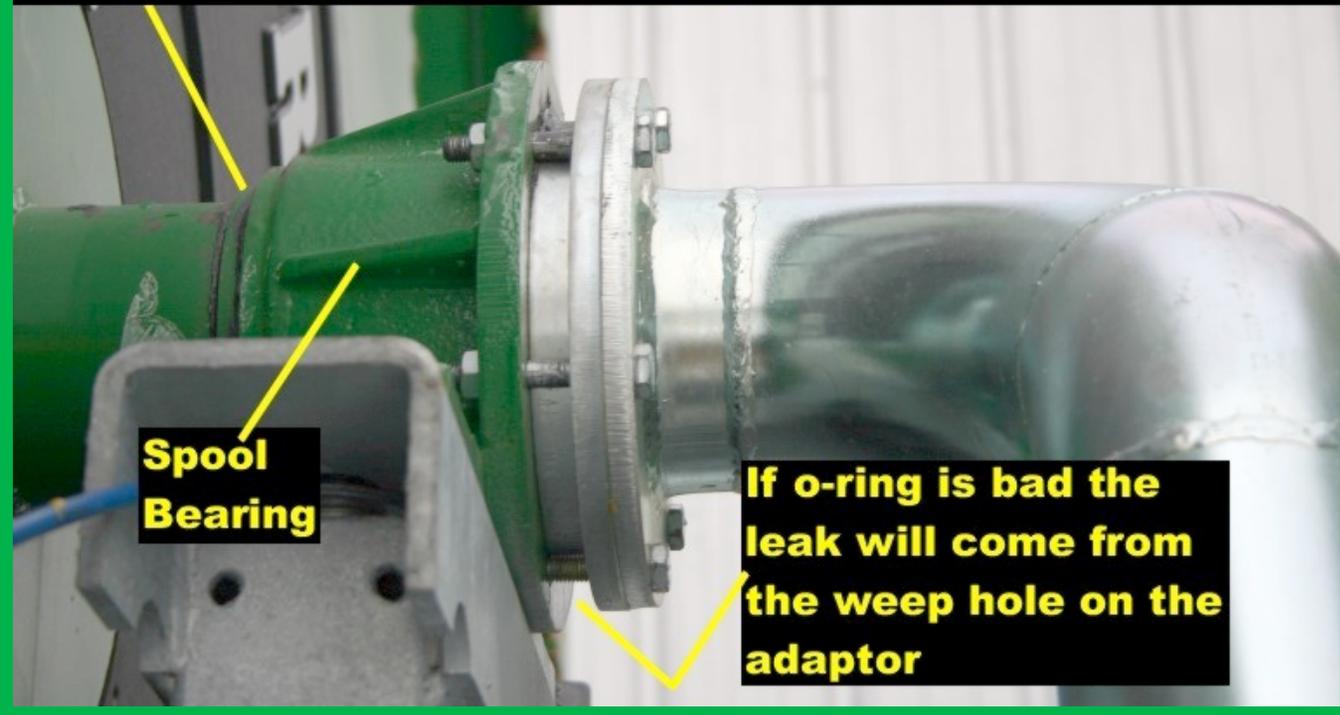
**If leak occurs on this side of bearing it is normally caused by bad threads on spool axle and/or spool nut. Another cause could be if the bonding agent has gone bad.**
